# Home Report

# Single Survey

## Survey Report on:

| <b>Property Address</b> | Chris-Lynn,<br>4 Knockhouse Road,<br>Crossford,<br>KY12 8YX |

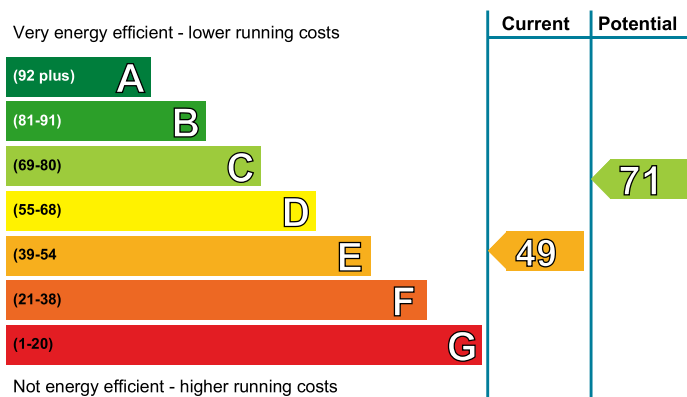
## Energy Efficiency Rating

This graph shows the current efficiency of your home, taking into account both energy efficiency and fuel costs. The higher this rating, the lower your fuel bills are likely to be.

Your current rating is **band E (49)**. The average rating for EPCs in Scotland is **band D (61)**.

The potential rating shows the effect of undertaking all of the improvement measures listed within your recommendations report.

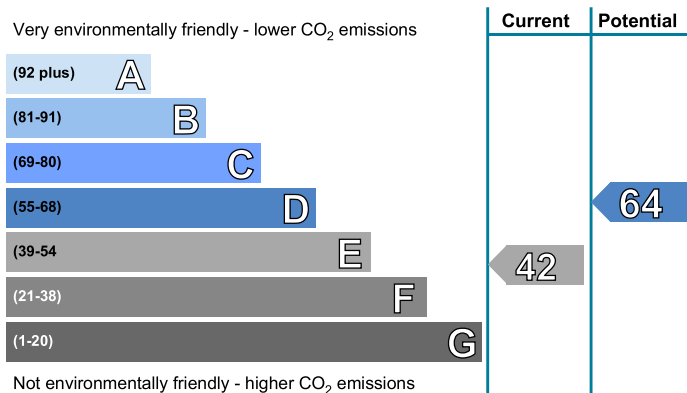
## Environmental Impact (CO<sub>2</sub>) Rating

This graph shows the effect of your home on the environment in terms of carbon dioxide (CO<sub>2</sub>) emissions. The higher the rating, the less impact it has on the environment.
